THE MAINTENANCE OF LIFEBOAT: A CASE STUDY OF MV. MAJU 99

This research was conducted at KM. Maju 99 which is a fleet owned by PT. Pranata Lines. This ship built in 2006 is a type of cargo ship. The ship has the callsign POXO. km. Maju 99 is sailing under the Indonesian flag and the ship is also 96.25 meters long. The type of lifeboat found on KM. Maju 99 is an open lifeboat type.

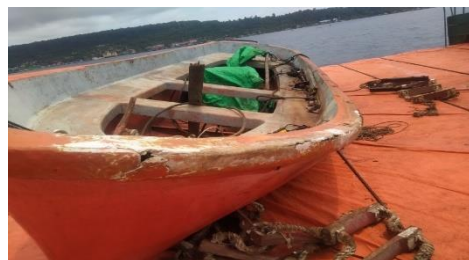
Damage to the lifeboat at KM. Maju 99 occurred in November 2020 in Manokwari Regency, West Papua Province which resulted in damage to the left hull of the lifeboat and a leak at the bottom of the lifeboat caused by a collision with the hull caused by the wire davits (goddesses) above the ship got entangled and slipped so that it got out of the lane. During the process of lowering the lifeboat, the weather around the area was cloudy and windy.

Figure 2. Condition of Damage to Lifeboat at KM. Forward 99

Lifeboat maintenance at KM. Forward 99 is not optimal because often sailing on short voyages or short shipping lanes is one of the reasons for the lack of time in carrying out lifeboat maintenance. Lack of crew knowledge about how to maintain lifeboats in KM. Maju 99 is an obstacle to the lack of optimal maintenance of lifeboats. As for other obstacles, the lack of maintenance of lifeboats is caused by the lack of availability of spare parts or spare parts.

- a. Conduct training for the ship's crew regarding proper and correct maintenance of lifeboats in accordance with maintenance procedures in accordance with the provisions of SOLAS 1974 and the PMS (Plan Maintenance System) on board the ship.
- b. Make a request for spare parts to the company so that there are no obstacles in the implementation of the lifeboat.
